Pavement Design at Coast Guard Air Station Clearwater

Carly A. Campbell, Kimberlee L. Capp, Tyler C. Henning, Jessica S. Wright
Department of Civil Engineering
United States Coast Guard Academy

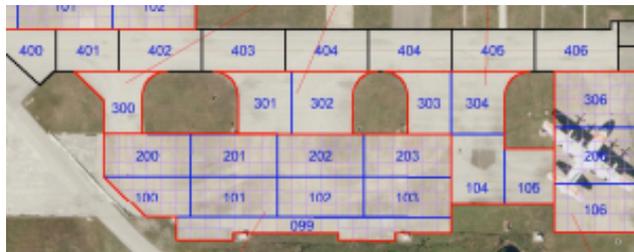
Figure 2 Air Station pavement sections

The HMA areas located between the C-130 aprons vary in condition. The HMA sections to be analyzed are all located in between two patches of grass and therefore were evaluated separately. In Figure 1 below, the aforementioned sections are; 300, 301, 302, 303, and 304. Due to the different conditions, three separate options were considered for redesigning these areas. The first option is using fog sealant over sections 300, 303 and 304. This is because the area displayed only weathering. While fog seal is a useful way to seal weathered, oxidized pavement, or pavement containing small cracks, the FAA warns that this type of surface treatment is typically limited on airfields due to decreased friction, debonding, and raveling of the asphalt. Furthermore, in order to stay intact the seal would have to be reapplied every 2-4 years. Therefore, with aircraft safety
